# TOWARDS NET ZERO RENOS

## CASE STUDY

This is a 1970's bungalow in SW Ontario. The homeowners are very concerned with greenhouse gas emissions so have already installed solar panels and own electric cars. They would like to do more, but are concerned with air quality (mould) growing in the house and cold spots.

**TARGET:** Net Zero Home Renovation

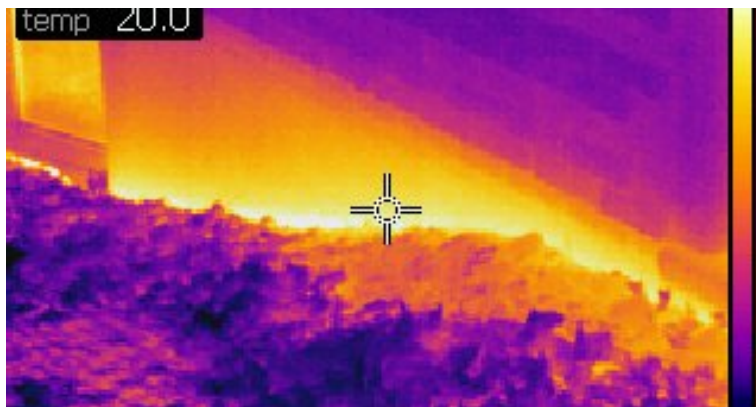
Heat loss through the basement was high

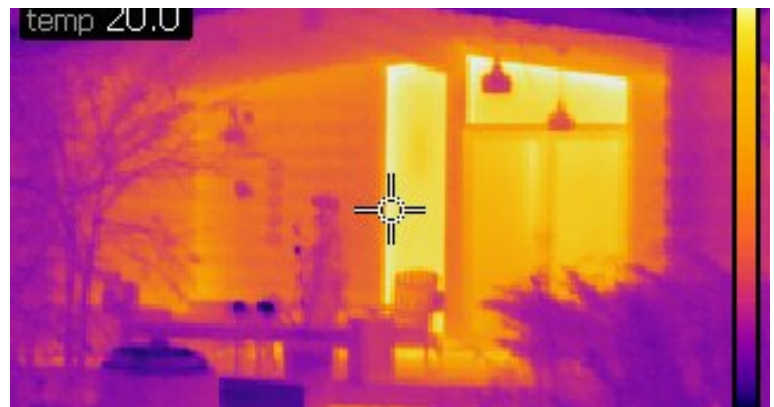
The front door and ceiling heat loss was high

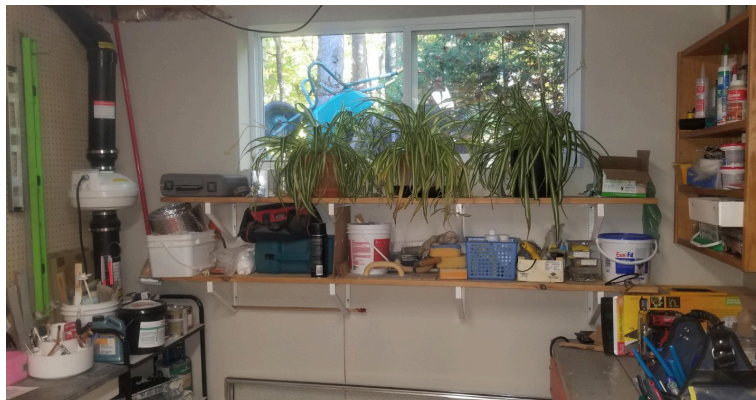
Customer already had soil gas extraction fan.

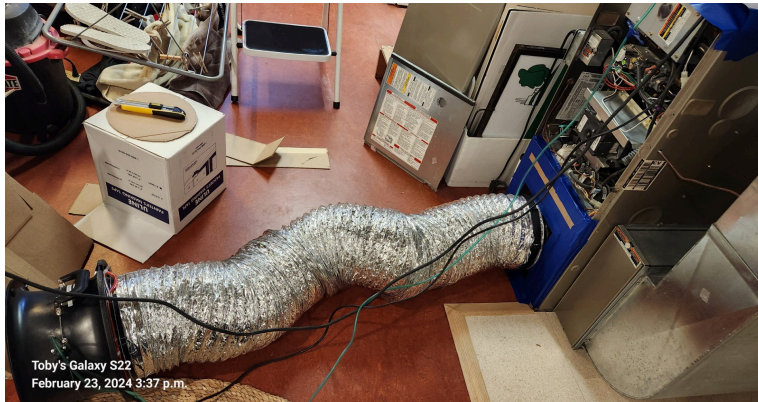
Measuring duct leakage - results inconclusive with this method.

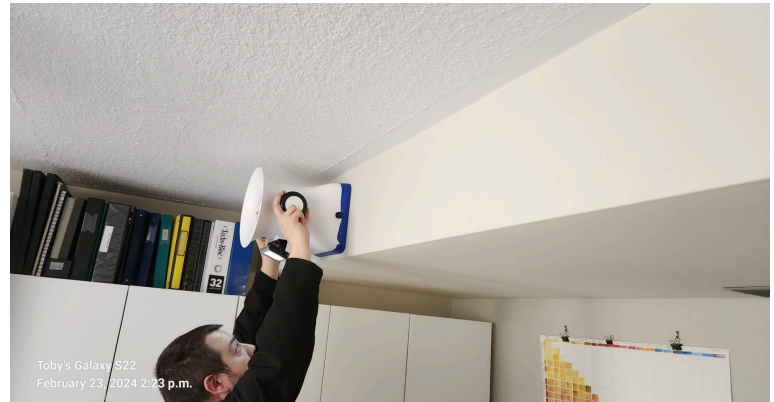
Checking supply duct flow of all registers to estimate leakage.

Duct flow summary. Flow through the furnace = 824cfm, registers=654, = 21% leakage.

A disconnected duct was found leading to about 1/3 of the house so heating and ventilation air was not being delivered. Dampers were closed shut, and the main trunk was increased in size and all ducts sealed. The kitchen and dining room is now much warmer (and cooler in the summer), the bedroom is much more comfortable as a result of the duct improvements. It's hard to find a contractor to do the small jobs.

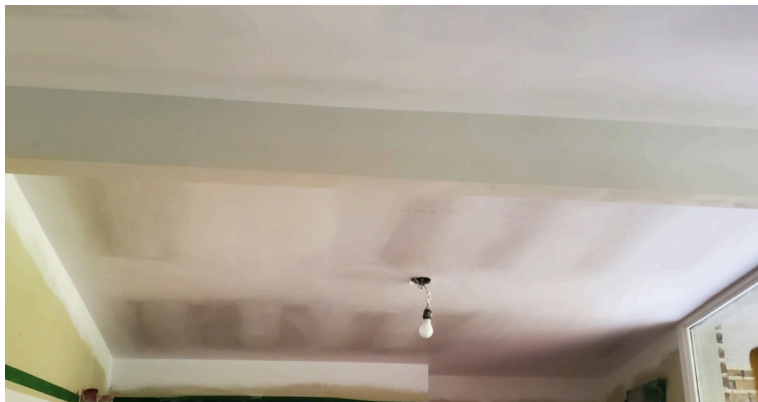
Insulation was added to the cathedral ceiling

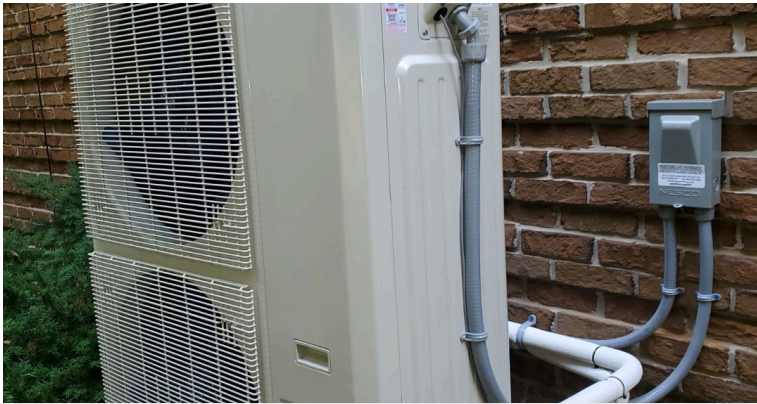
The new air source heat pump
