# TOWARDS NET ZERO RENOS

## CASE STUDY

**TARGET:** Net Zero Home Renovation

**LOCATION:** Saskatoon, Saskatchewan

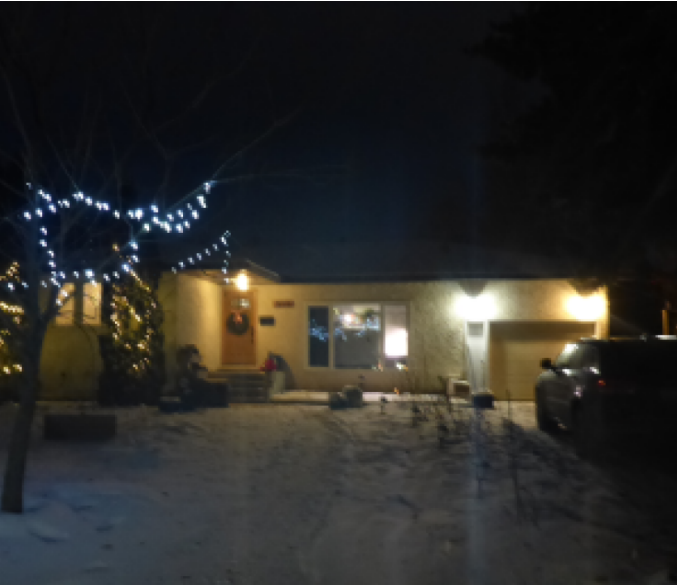
This bungalow was built in the 1956. MDSF was added to most of the basement prior to the project. The attic had wood chips and fibreglass, and the exterior of the home has old stucco. The furnace and DHW were aging with pilot lights burning year round. The walls have R-8 batts, and a leakage rate of almost 4 ACH.
